a. The Accident. F-4B, BUONO 148401, assigned to MARINE FIGHTER ATTACK SQUADRON THREE ONE TWO (VMFA-312) stationed at Marine Corps Air Station (MCAS), Beaufort, North Carolina, crashed and burned approximately one mile short of runway 22 MCAS, Beaufort on 29 January 1968 at 1618 (R). The pilot, MAJ (b) (6) USMC, (b) (6) and the Naval Flight Officer (NFO), 1ST LT (b) (6) USMC, (b) (6) successfully ejected, however, the latter received major injury. The aircraft sustained ALFA damage. There was minor damage to government property and no damage to private property.

a. The most probable cause of this accident was the failure of the bleed air duct transition section, P/N 10624-22. The cause of the failure was fatigue originating in the welds.

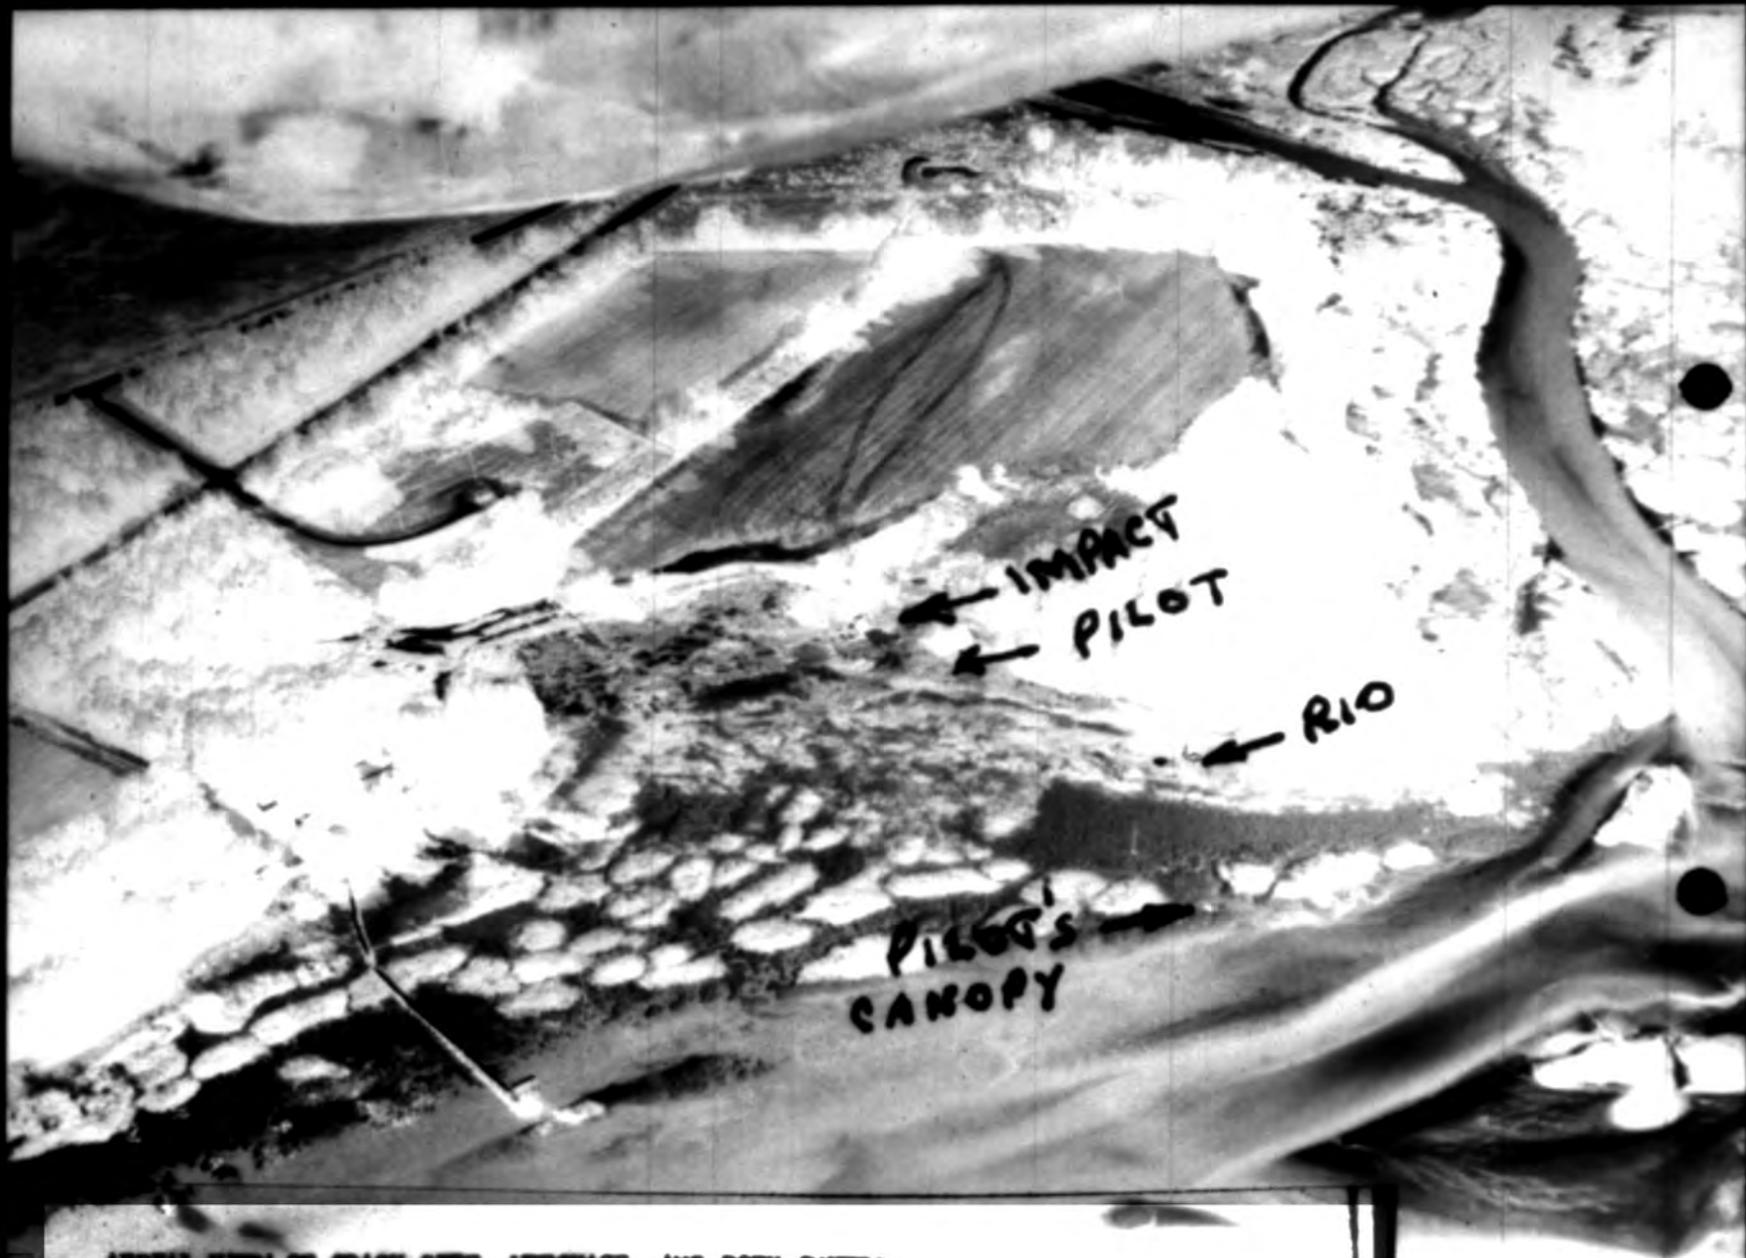
AERIAL VIEW OF CRASH SITE, WRECKAGE, AND BOTH CHUTES.

NOTE RUNWAY 22 OVERRUN IN UPPER LEFT HAND CORNER.

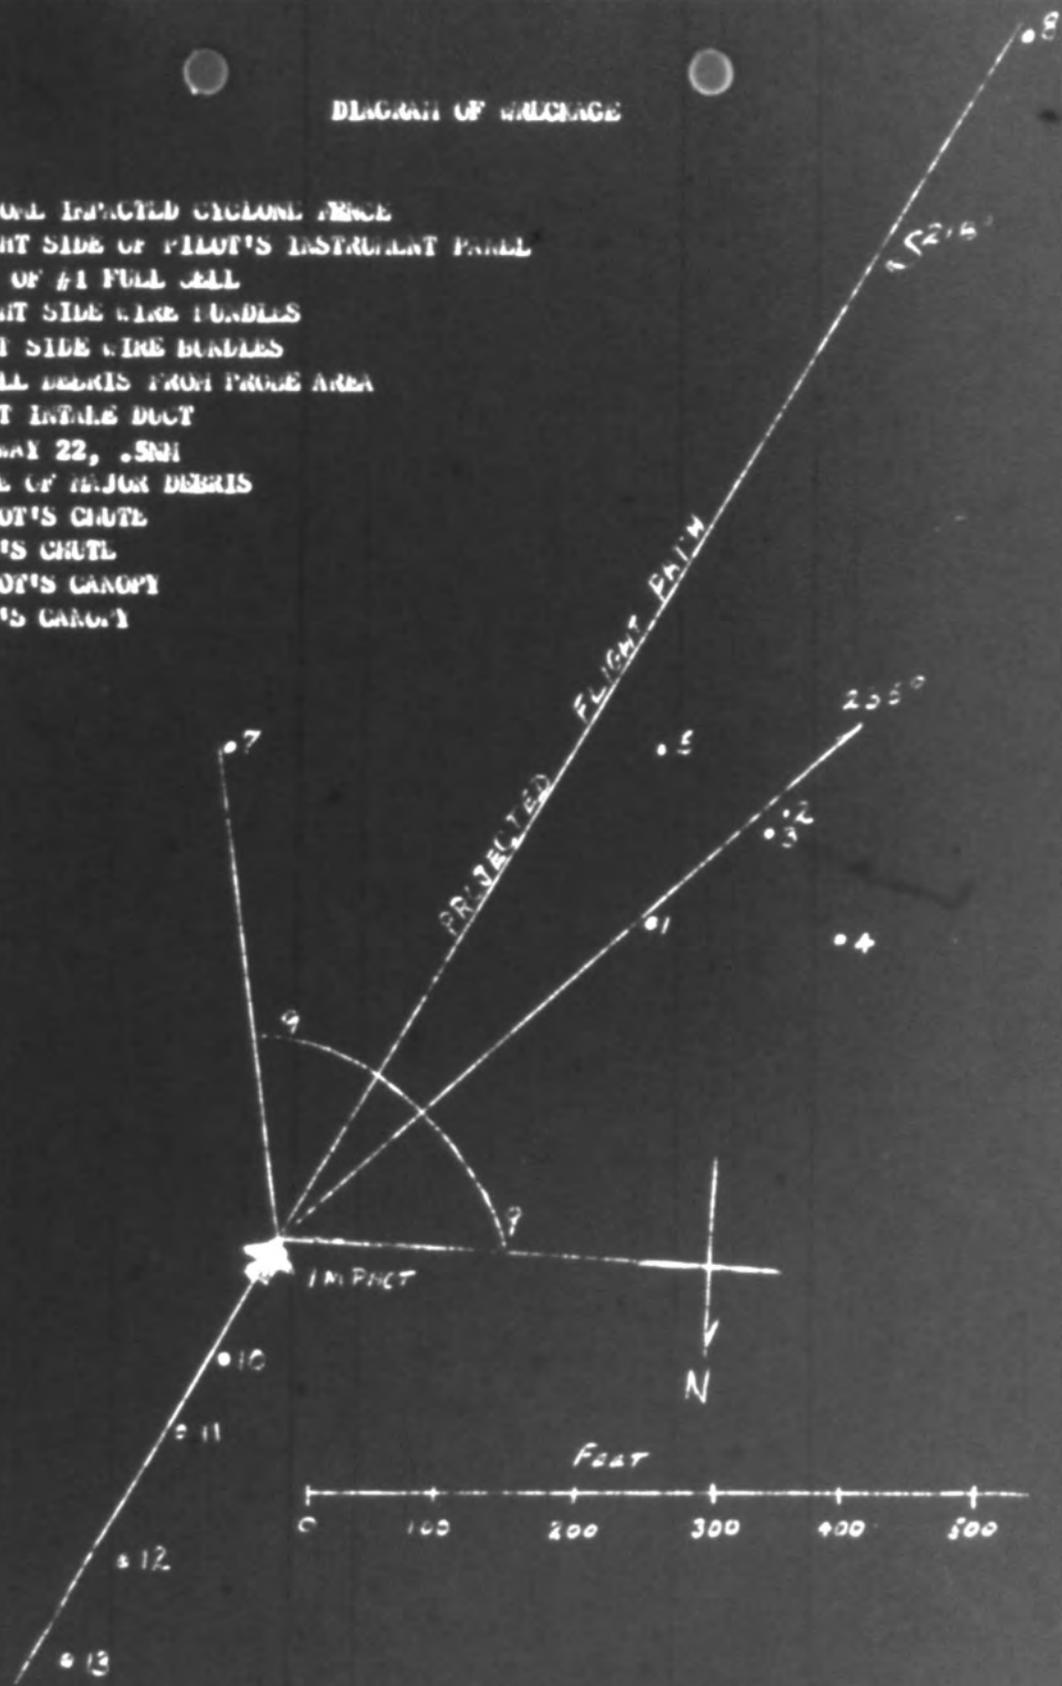
DIAGRAM OF WRECKAGE

1. WINDWARD IMPACTED CYCLONE BRICE
2. RIGHT SIDE OF PILOT'S INSTRUMENT PANEL
3. TOP OF #1 FULL CELL
4. RIGHT SIDE WIRE BUNDLES
5. LEFT SIDE WIRE BUNDLES
6. SMALL DEBRIS FROM PROBE AREA
7. LEFT INTAKE DUCT
8. RUNWAY 22, .5MI
9. CORE OF MAJOR DEBRIS
10. PILOT'S CHUTE
11. RIO'S CHUTE
12. PILOT'S CANOPY
13. RIO'S CANOPY

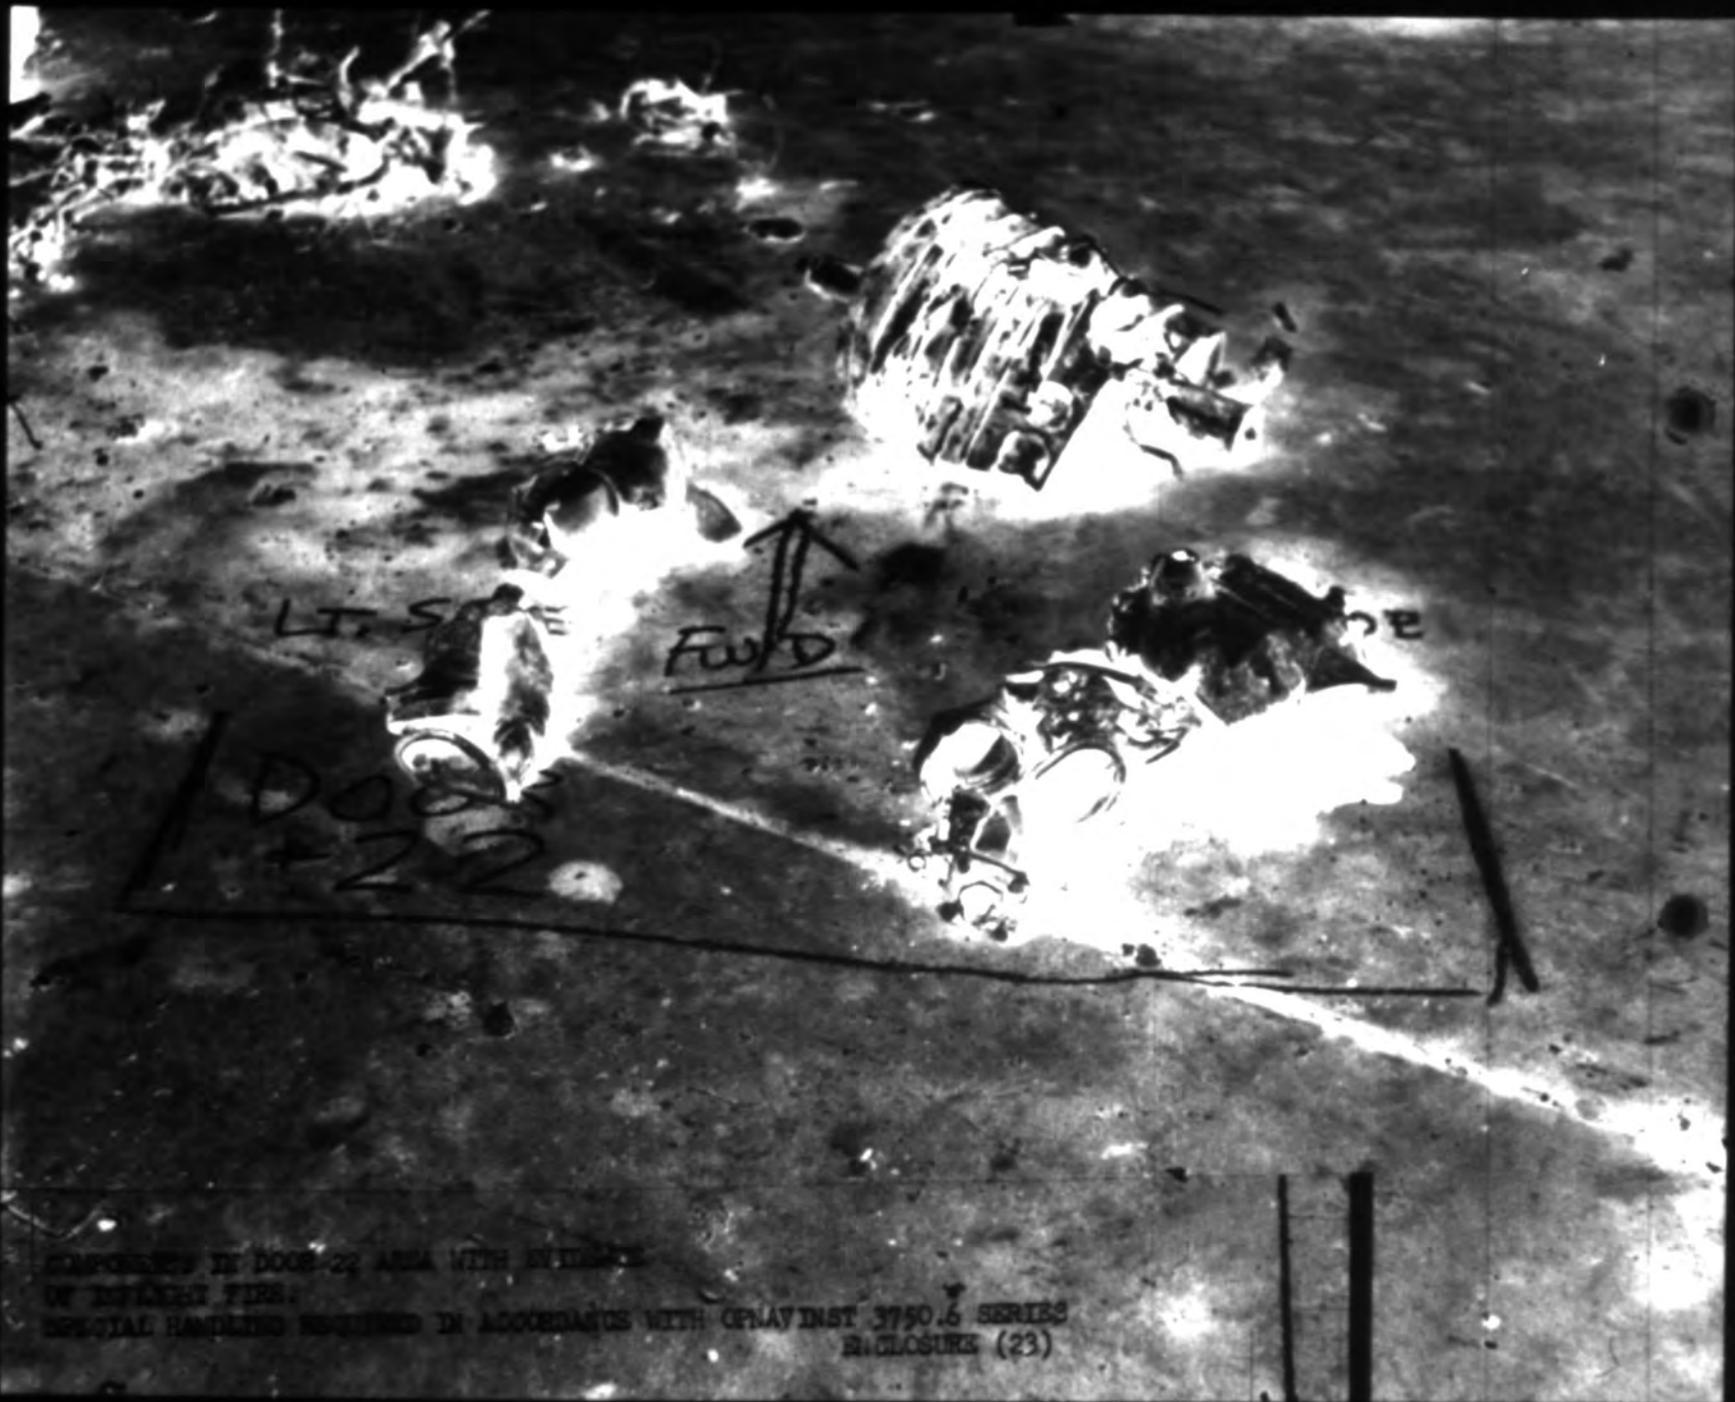
COMPONENTS IN DOGS-22 AREA WITH EVIDENCE
OF IMPACT FIRE.

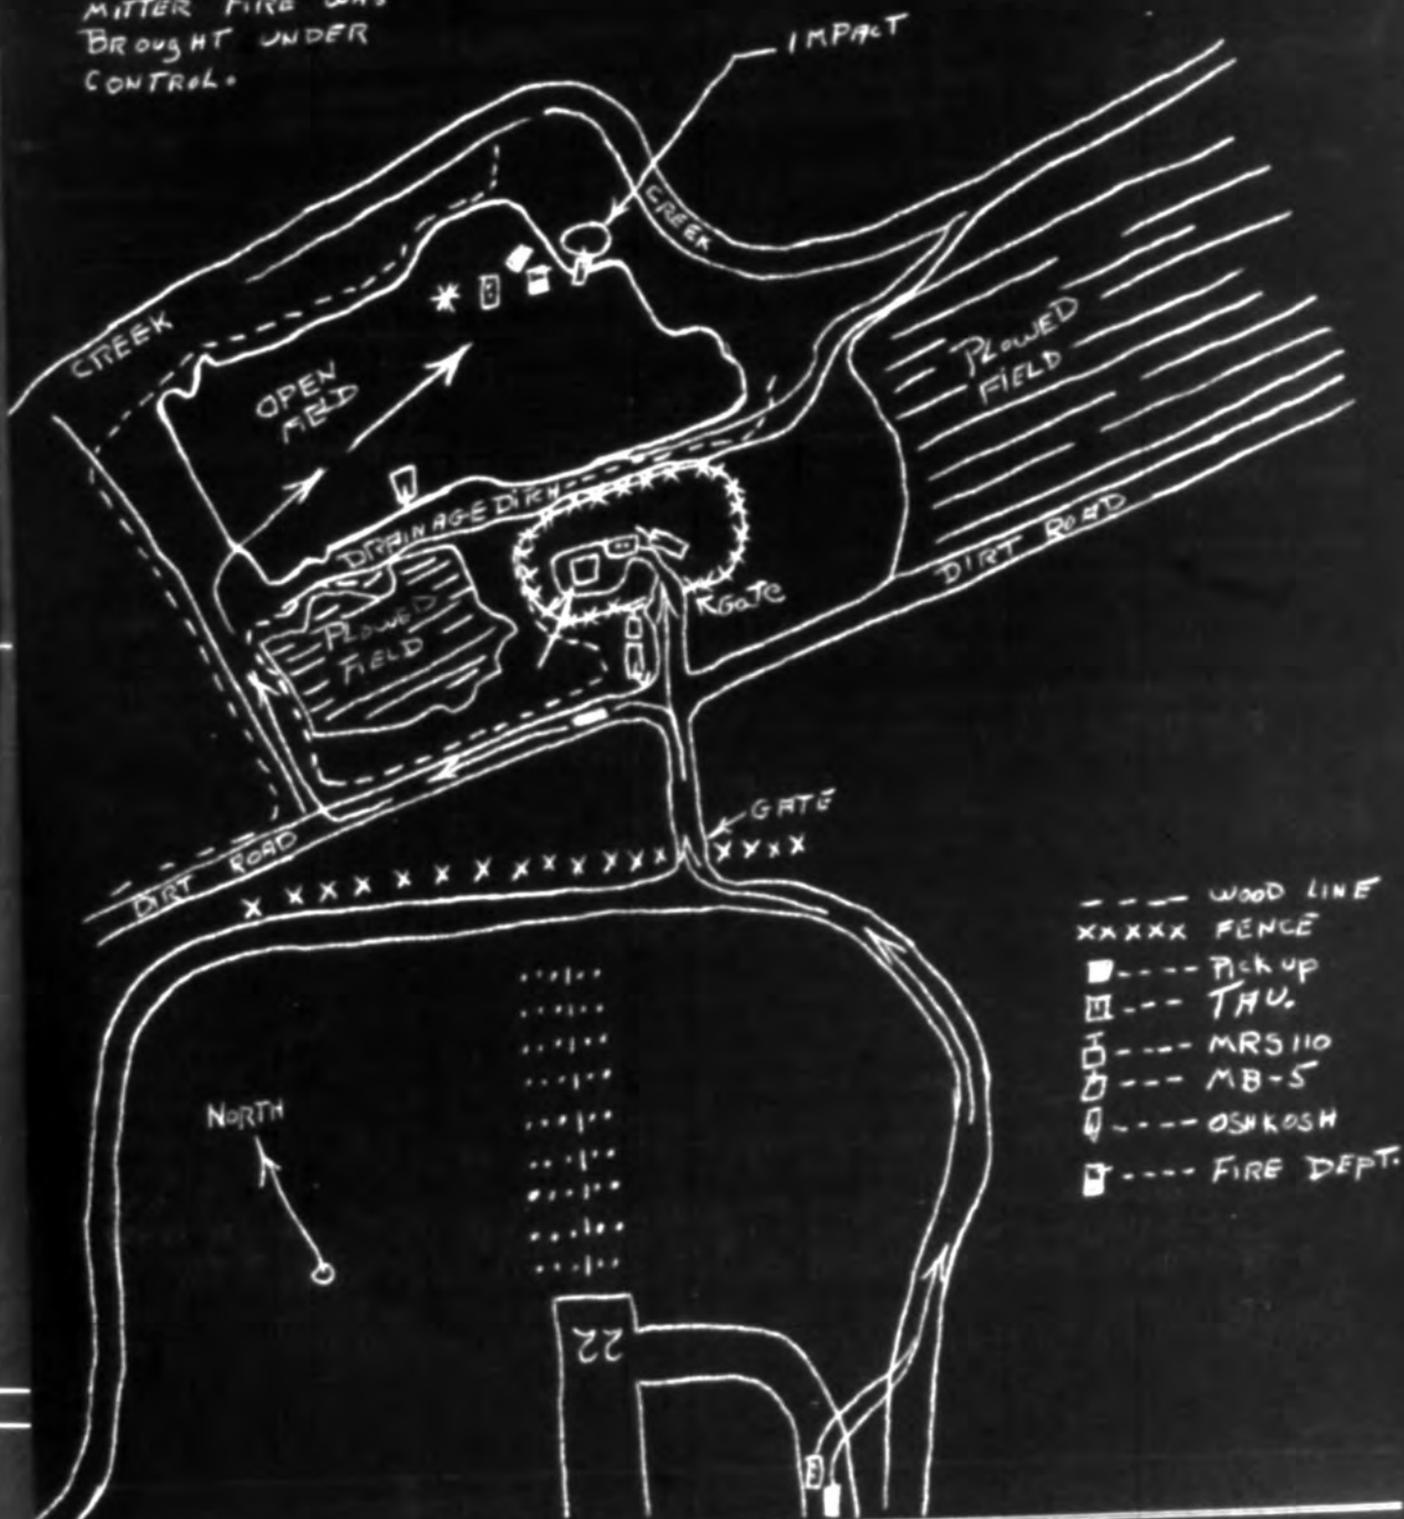
DIAGRAM OF INCIDENT SHOWING WIND, DIRECTION, APPROACH OF EQUIPMENT, POSITION OF AIRCRAFT, DISTANCES, ETC.
 (Maps and photographs should be included, if significant)

* TAU WAS BROUGHT OVER AFTER TRANSMITTER FIRE WAS BROUGHT UNDER CONTROL.
